# Hydrothermal monitoring using embedded sensors of the actual roof system of the Prado Museum

J. Sanchez \*, C. Andrade, J. Fullea

*Institute of Construction Sciences "Eduardo Torroja" (IETcc) – CSIC, Serrano Galvache 4, 28033 Madrid, Spain*

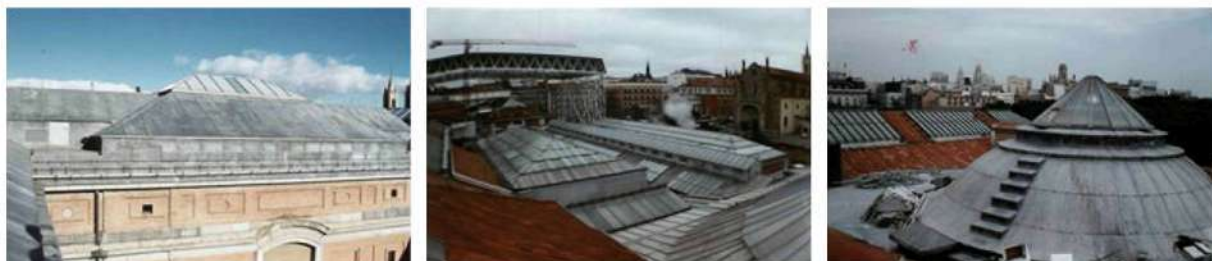
Two different views of the roof of the Museum during refurbishment are shown in Figs. 1 and 2. The geometry and irregularities of the roof are very high, apart from the fact of its large extension. The old roof was made on ceramic tiles as can be appreciated in the centre of Fig. 1 in its bottom-left part and in the right view of the figure. The roof is divided into sections separated by glass skylights that allow light into the halls located beneath the roof. The

**Fig. 1.** Three aspects of the roof of the Museum. It is possible to appreciate the ceramic tiles of the old roof in left-bottom part of the figure in the centre and in that in the right part.

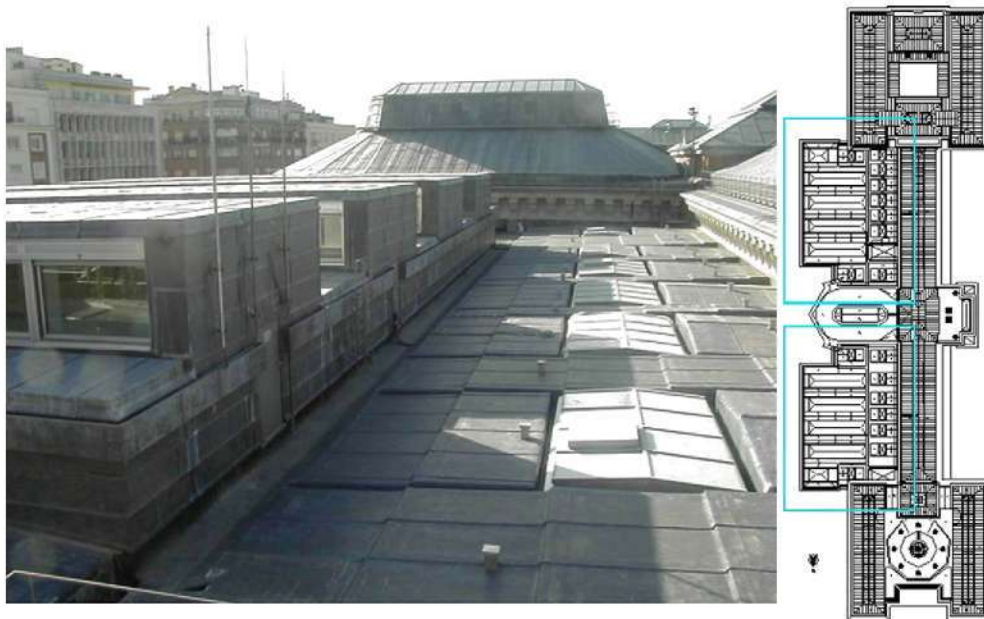
Museum has two similar winds: North and South as is shown in the drawn of Fig. 2.

**Fig. 2.** In the left is shown the aspect of the roof of the Museum with the lead cover and in the right is given the lay-out of the roof.

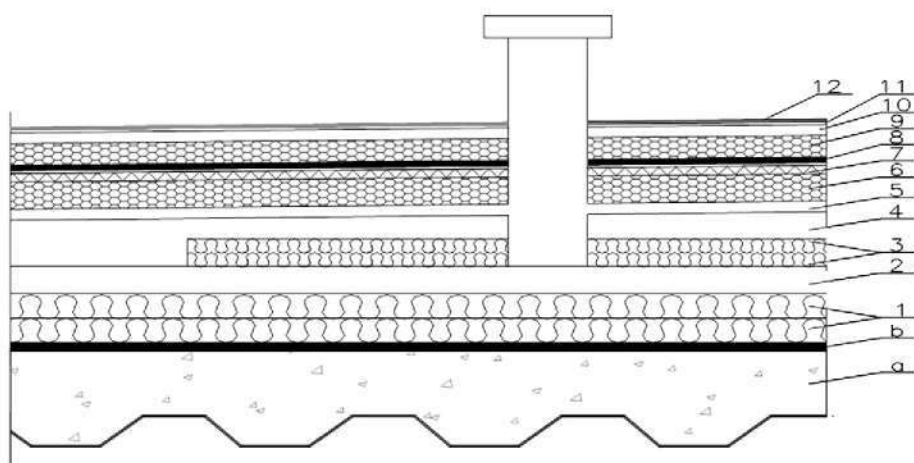
The new cover designed is an “inverted cover” composed of a multilayer system in which the upper cover is lead and the rest of the layers are listed in the caption of Fig. 3. The roof had an inclination for water draining of 1.5%. Although it is a multilayer system the only coat with barrier responsibility was the liquid waterproofing material named SIL (Fig. 4 left part): it is a aqueous dispersion of an acrylic copolymer that it is applied in layers as a liquid which hardens and that make a bonding with the support. It is a bi-layer having in the middle a glass textile to reinforce it (Fig. 4 centre). This waterproofing coat is applied on a support made by a mortar with lightweight aggregates and is covered by a rubber as is shown in Fig. 4 left. The rest of the layers are on mortar, thermoformed polystyrene (for thermal isolation), geotextile and, the final lead coat. Only the SIL was designed to be full waterproofing while the lead cover and the rubber and geotextile, were not designed to overlap in such a manner that could have been also tight. This is theoretically correct due to the ease to apply the liquid waterproof, its continuity and adaptation of irregular geometries. However, it is very difficult a full control of the thickness of the polymer applied and the correct execution of the entire singular and intersection points that the roof has.

**Fig. 3.** Elevation corresponding to the roof section: (a) concrete, and (b) liquid waterproofing (SIL), (1) insulation, (2) cement mortar, (3) insulation, (4) cement mortar, (5) vapour scattering layer (thermoformed polyethylene), (6) mortar with arlite, (7) liquid waterproofing (SIL), (8) floating waterproofing (rubber), (9) mortar with arlite, (10) cement mortar, (11) Geotextile, (12) Lead.

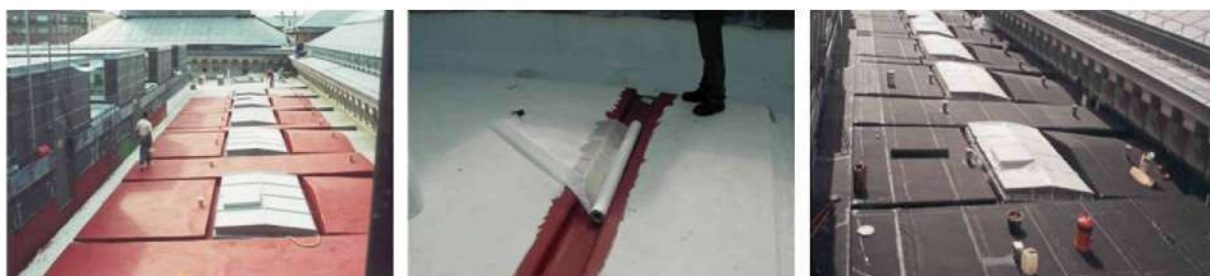
**Fig. 4.** Liquid waterproofing (SIL).

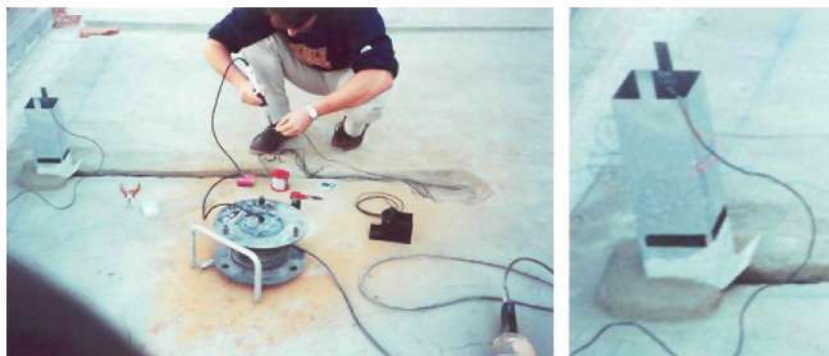
Fig. 10. Sensor location and installation.

The sensors were positioned during the refurbishment work (Fig. 10). The liquid water and temperature sensors were placed between each one of the roof layers and in two different positions, with one close to a “breathing” chimney (Fig. 10) and the other further away. Being designed as the main barrier against rain water, the strain gauges were placed on the waterproofing membrane layer–SIL–(Fig. 3) in order to monitor its performance with respect to the risk of cracking. The relative humidity sensors were placed at several positions in the waterproofing layer and below the surface lead layer.

Table 1 lists all the sensors installed in the roof. The letter corresponds to the type of sensor, the first digit indicates one of two possible positions within a height or layer, and the second digit indicates the roof layer it is on. Fig. 10 shows the arrangement of the sensors closest to a chimney.
